## Intelligent Aging Evaluation of Polymeric Insulators by Inclined Plane Test

**Abstract**—Though polymers have tremendous advantages, but due to various disadvantages their usage has been limited. The main limitation is the surface ageing property of polymeric insulators. Though research on polymeric materials has been carried out, ageing properties are not determined exactly. In the present work, inclined plane tracking and erosion tests were carried out on specimen insulator material with different pollution severity prepared artificially. The effect of spacing between the electrodes used was studied by varying the distance between the electrodes. Further tests were also conducted on a section of the full-scale insulator of 66kV. Tests were conducted on specimen insulator material for 100 hours and the test samples were observed for their hydrophobicity property. The details of the experimental setup, the procedure followed, the results, and the discussions are presented in this paper. From the study carried out it was found that a lower severity is vulnerable to ageing of polymeric insulators, which is a valuable result as the surface condition along with electrical stress pl

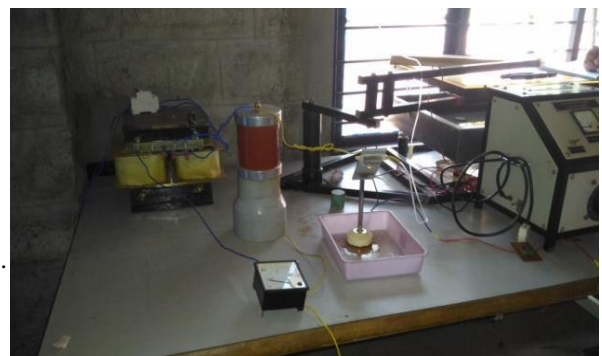
Fig. 3. Experimental test set-up for inclined plane test.

The experimental test setup is as in Fig. 3. The specimen was mounted on an inclined plane. The arrangement was placed in a tray so that the contaminant after flowing on the specimen drops, down and gets collected in the tray. All the other devices shown in the schematic diagram can be observed in Fig. 3.

The laboratory setup used for the inclined plane facility used for ageing test is shown in Fig. 3. The arrangement is done as per the circuit schematic presented in Fig. 2.

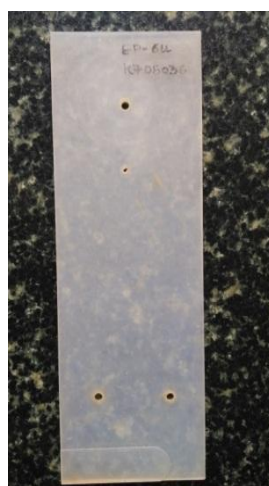
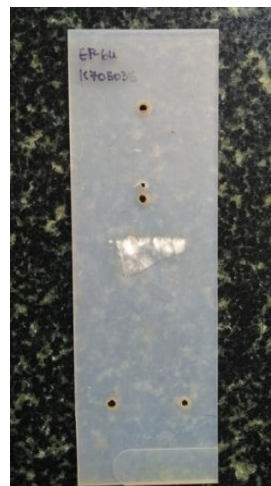
Tests were conducted on Samples A, B & C as per the procedure described in Section B, with a 4.1cm distance between the electrodes and 2kV applied. Figure 4a shows the photograph of Sample-A before conducting the test. Figure 4b shows Sample-A after the test.

Fig. 4a. Specimen A before testing

Fig. 4b. Specimen A after testing

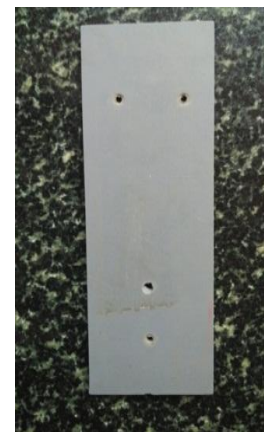
Figure 5a and Figure 5b show the photographs of Sample-B before and after conducting the test respectively.

Fig. 5a. Specimen B before testing

Fig. 5b Specimen B after testing

From the results in Table-1 and Table-2 and the photographs of the samples in Figure 4b, Figure 5b, and Figure 6b it can be observed that 1% severity and 4.1cm distance between the electrodes was not

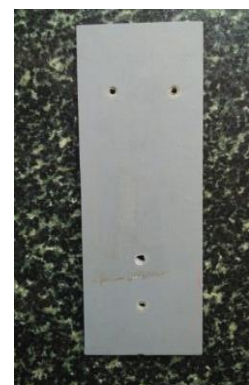
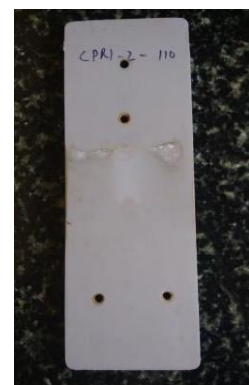
Similarly, Figure 6a and Figure 6b show the photographs of Sample-C before and after conducting the test respectively.

Fig. 6a. Specimen C before testing

Fig. 6b. Specimen C after testing

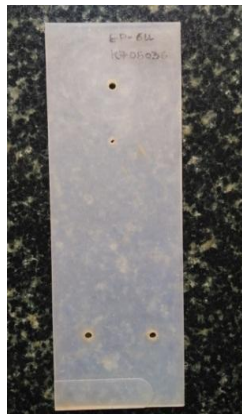
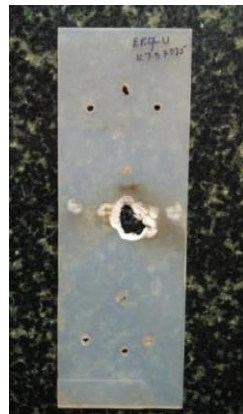
Tests were conducted on Samples A, B & C as per the procedure described in Section II B. Fig. 7a and Fig. 7b show the photograph of Sample-A before and after conducting the test. Sample-A was observed to deteriorate. Fig. 8a and Fig. 8b show the photographs of Sample-B before and after conducting the test. Sample-B has slightly deteriorated. Fig. 9a and Fig. 9b show the photographs of Sample-C before and after conducting the test. It was observed that Sample-C has slightly deteriorated.

Fig. 7a. Specimen A before testing

Fig. 7b. Specimen A after testing

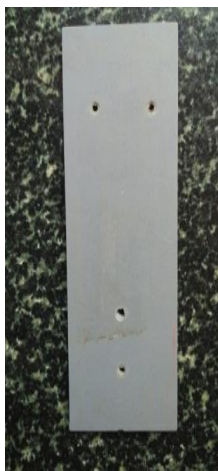
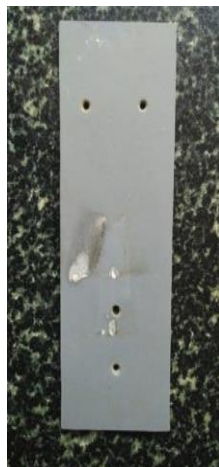
Fig. 8a. Specimen B before testing

Fig. 8b. Specimen B after testing

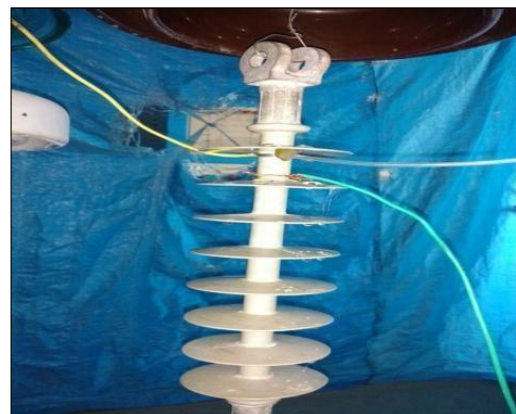
Fig. 10. Experimental set up on a section of 66kV polymeric insulator

From the above analysis of Inclined Plane Test on samples, a test for a full-scale insulator was conducted. It was observed from the results in Section III, that the severity of 0.1% is higher, therefore 0.1% severity was selected for the Full-scale Insulator. Test were carried out on one section of polymeric insulator, to analyse the effect of insulator geometry. One section of the polymeric insulator was considered for the experiment as in Fig. 10.

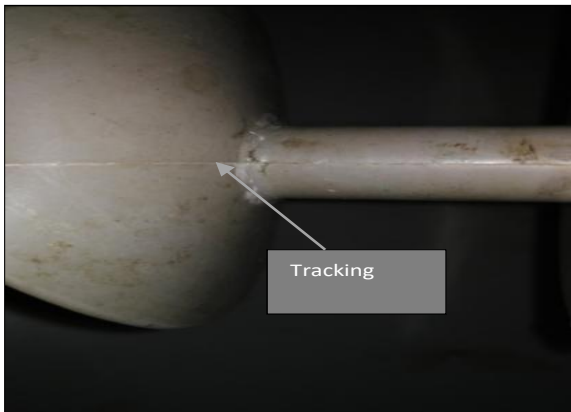
Fig. 11. Tracking on a section of 66kV polymeric insulator after Inclined Plane Test.

Test were conducted for about 2 hours. A small track has been formed at the parting line as shown in Fig. 11 for an applied voltage of 2.6kV. The deterioration of the section of the insulator was not much so, it can be inferred that more hours of the test may be required which has to be carried conducted for future work.

A test conducted on a section of a 66kV polymeric insulator showed light tracking with an applied voltage of 2.6kV for 2 hours. Since the tracking observed was very light, further testing with more hours may be carried out before concluding the effectiveness of the severity.
